## **KUN-MING AMMUNITION AND SUPPLY DEPOT** TA-PAN-CHIAO, CHINA

# KUN-MING AMMUNITION AND SUPPLY DEPOT

A previously identified munitions storage site is located at 25-03N 102-50E, 7 nautical miles (nm) east of Kun-ming, China (Figure 1). This installation consists of a munitions storage area, a housing and administration area and a housing and storage area (Figure 3). The site is road-served only.

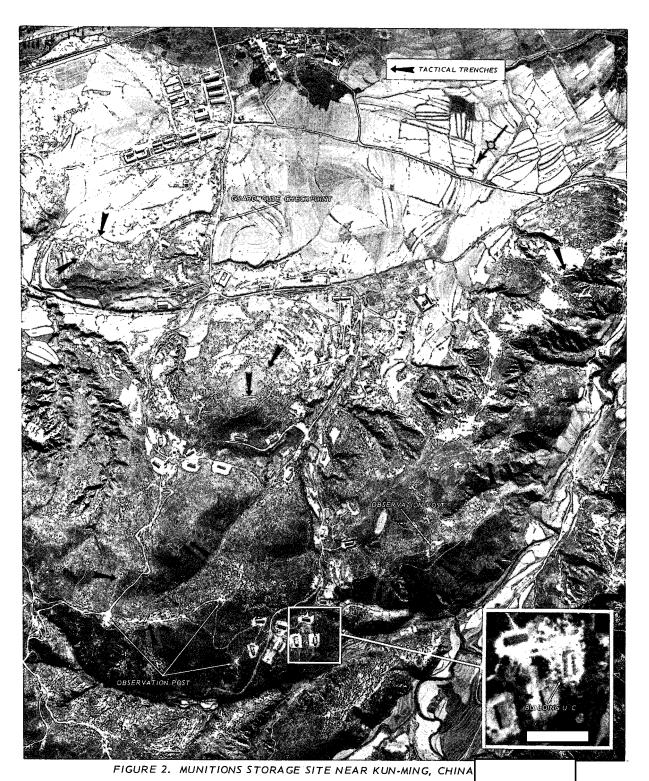
A refurbishing of Buildings 3 and 4 appeared to be in progress at
the time of the photography. Several white piles visible
near these buildings are probably construction materials to be used in
connection with the refurbishing.
Building 19, which was under construction (Inset, Figure 2), appears complete on photography

Perimeter security is provided by a system of tactical trenches located in the highest areas of the site (Figure 2). Observation posts are situated at strategic points near the tactical trenches in the munitions storage area (Figure 2). Security fencing was not visible in any area of the site. Vehicular traffic into the munitions storage area is controlled by a guardhouse/checkpoint at the location indicated in Figure 2.

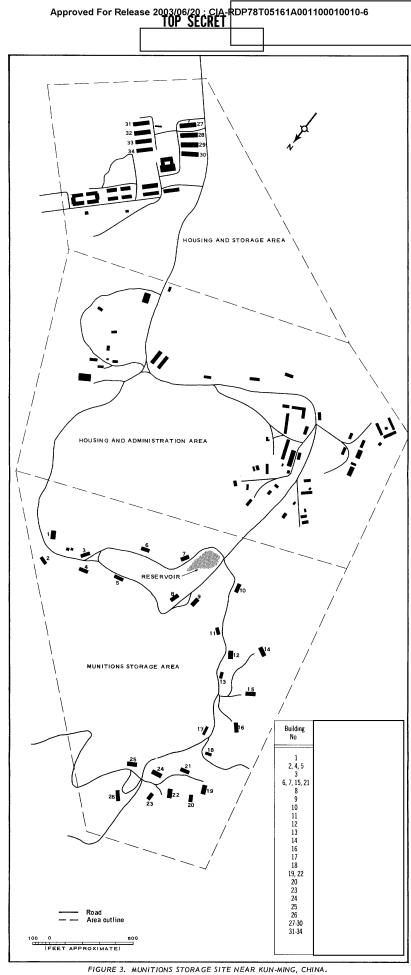
Facilities in the munitions storage area include 26 gable-roofed storage buildings (Buildings 1-26, Figure 3) and 2 small support buildings. A small water reservoir and several small water basins are located in this area, probably for use in case of fire. Most of the storage buildings have end walls of heavy construction, probably for blast protection. Additional blast protection is provided for many of the storage buildings by their location in cutbacks in the hillsides. Buildings 19-25, because of their location with respect to each other, are provided with very little blast protection.

This area, consisting of 8 warehouses (Buildings 27-34, Figure 3), ll barracks and l messhall, probably provides storage for nonexplosive type military equipment and additional housing for the munitions storage area personnel.

All measurements have been made by the NPIC Technical Intelligence Division with the exception of Building 19 which were made by the CIA/IAD project analyst. The location of Building 19 on the line drawing was also accomplished by the CIA/IAD project analyst.
